## **Problem Solvers**

Screening Machine Cover Clamp

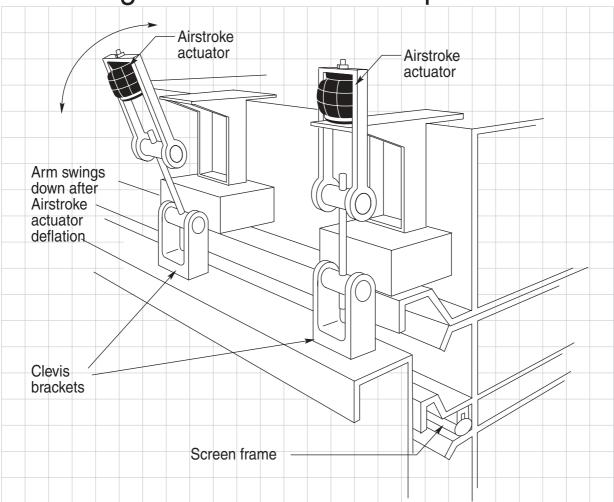
Deterioration of seals on the lids of gyratory screening equipment prevents them from sealing tightly, resulting in operational failure and machine damage.

The use of Airstroke actuators on lid brackets to help achieve optimum sealing and move-resistance.

Proper force is consistently applied to the lids, compensating for the deteriorated seals and improving overall performance.
